Investigation on a collapse accident of guyed portal towers caused by strong wind

Abstract. A collapse of 3 guyed portal towers in a 220 kV transmission power system were caused by short period of strong wind. In order to unmask accident, various methods are used, such as scene investigation, material test and FE method. The reasons caused the collapse accident are obtained in this paper, and some improvement measures are recommended for sake of continuing maintenance.

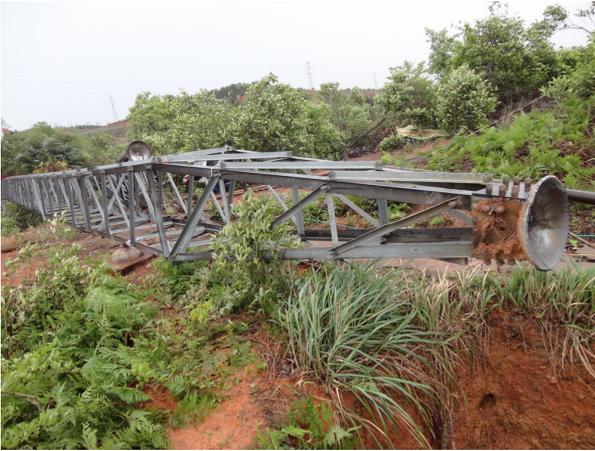
Fig. 1. The collapse accident of the #54 tower

The accident occurred on April 24th, 2012. The collapses of three transmission power towers named respectively #54, #55 and #56 in the 220 kV transmission power system are line towers. The collapse accident of the #54 tower is shown in Fig. 1. The transmission power system spans 1834 km and came into service in January 2005. The transmission power system was designed under a wind speed of 25 m/s. The three towers broken down on the direction vertical to the transmission power line. Furthermore, the earth wire bracket of #57 strain tower also has been damaged. Discharge point was found at the #53 transmission power tower.

Base on the analysis above, the #54 ZH3-30 guyed portal tower is up to the requirement and resist the wind at a velocity of 25 m/s. Considering the discharge point of #53 strain tower and the insulator and anchorage point of #54 guyed portal tower, the collapse of the guyed portal tower wasn't caused by strong wind at one time. The main incentive of collapse is the disjunction of the spherical steel plate and the positing steel bar at the basis of the tower. Moreover, the length of the positing steel bar is only 40 mm. Fixed plane is not taken into account when designing. In summary, the disjunction happened firstly, and then the displacement continuing increase caused by the vibration which induced by strong wind, finally the tower collapsed because of the offset of gravity center.

Consequently, the main reason of the #54 220 kV guyed portal transmission power tower' collapse is the failure design of the tower basis. At the same time, the insufficient maintenance is also a reason that can't be ignored, it is the breakdown of the basis leg of the #54 caused the collapse of the three transmission power towers.

In order to prevent from collapse of transmission power tower, some improvement and measures should be taken. Especially, the design of the positing steel bar of the basis leg of the tower should be concerned. The tower that already constructed should install a fixed plane and lengthen the positing steel bar as well.

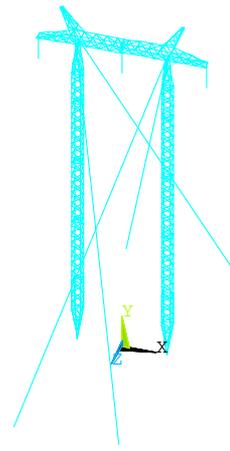
Fig. 2. The finite element model of GUYED portal tower

The finite element method is used to analyze the #54guyed portal tower (ZH3-30) under strong wind condition [4, 6]. The finite element model of #54 transmission power tower is shown in Fig. 2. It contains 1329 beam elements. Through the analysis, it shows that the maximum bearing wind velocity is 30.2m/s. When the speed goes to 30.2 m/s the shaft of cross arm yielded and the stress of the shaft exceeded the yield strength of Q345. As a result, the tower collapsed which is showed in Fig. 3 and Fig. 4. However, based on circumstance around the tower, the wind speed when the collapse occurred can be estimated reasonably below the maximum speed. It's necessary to consider the influence of fluctuating wind in the continuing works, in order to simulate the real loadings on the transmission power tower for the sake of safety.
