Beginning of cracking of masonry walls due to vibrating and noise effects of machines

Abstract. This paper deals with dynamic tests of the building with diesel generator and the process of determining the cause of the cracks in its walls. After initial measurements and FEM analysis, it was assumed that vibrations propagate to the structure through the base of the generator. Therefore, it was recommended to apply an elastic antivibration layer at the supporting base of the generator. However, the problem with cracks persisted and it was necessary to perform additional tests and analysis. Finally, acoustic simulation was performed and provided promising results.

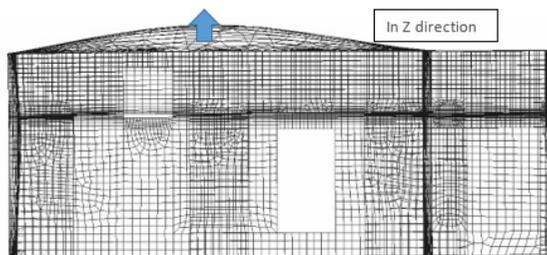
A numerical model has been developed before execution of an experimental test [5]. The FEM model has been created by shell elements with two different types of material concrete and masonry-walls. Some mode-shapes and their natural frequencies (Fig. 1) have been obtained after the preparation of the FEM model. Thanks to that, the best locations for sensor setup has been

Fig. 1. The first mode-shape ($f = 13.37$ Hz)

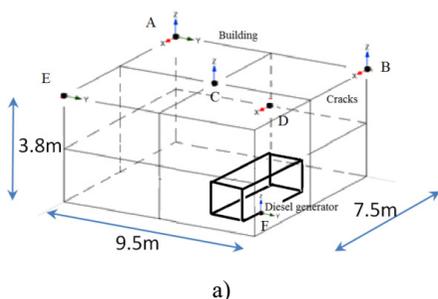
The first test was done in 2017. Accelerometers were mounted [6] during the measurement on the diesel generator (mainly MMF KS901.100) at point F. Besides that, eight accelerometers (PCB Piezotronics 393B31) were mounted at points A, B, C, D and E, respectively, to measure a response of the building (Fig. 2). Two operational states have been measured [7]: startup stage of the generator and operation of the generator at about 10 % of its power, but without full loading of the electrical system (generator ticking over).

Fig. 2. Sensor setup: a) scheme of all sensors, b) sensors at point A, c) sensor at point D

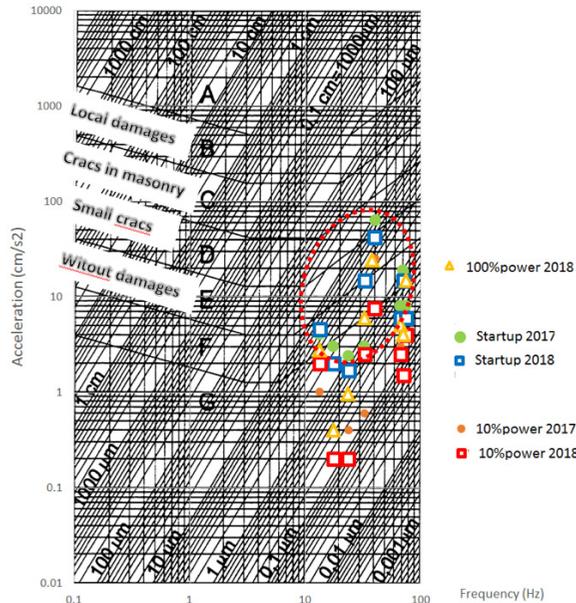
The acceleration amplitudes reached a level when small cracks can start to emerge (Fig. 3). Therefore, it was recommended to apply an elastic shock absorber layer at the supporting base of the generator.

Fig. 3. Evaluation of vibration effects on masonry structures according to [8]

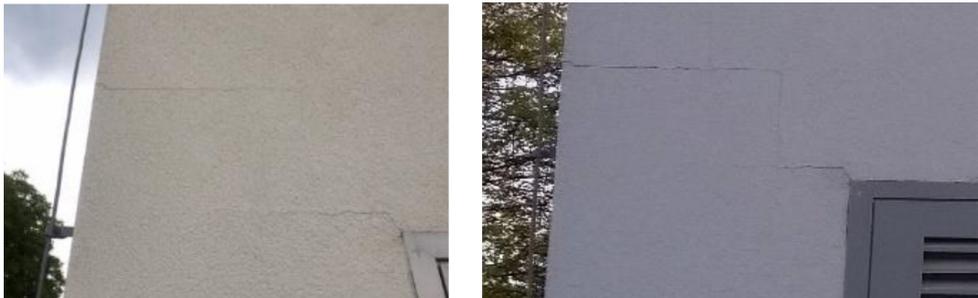
However, the problem with cracks persisted (Fig. 4) and it was necessary to perform additional tests a year later in 2018.

a) In 2017

b) In 2018

Fig. 4. Cracks on the wall of the building

The paper presented OMA performed on a building with diesel generator to determine the cause of the cracks in the walls. After adjusting the supports of the generator with a layer of elastic material in 2017, the problem did not cease. Therefore, we tried to perform the harmonic analysis using acoustic pressure. Finally, the results from the harmonic analysis revealed that some cracks can be also caused by acoustic pressure during the full operation state of the generator.

The owner of the building adjusted the supports of the generator and added a layer of elastic material-shock absorber layer-with height of 9 cm under the steel base of the generator.

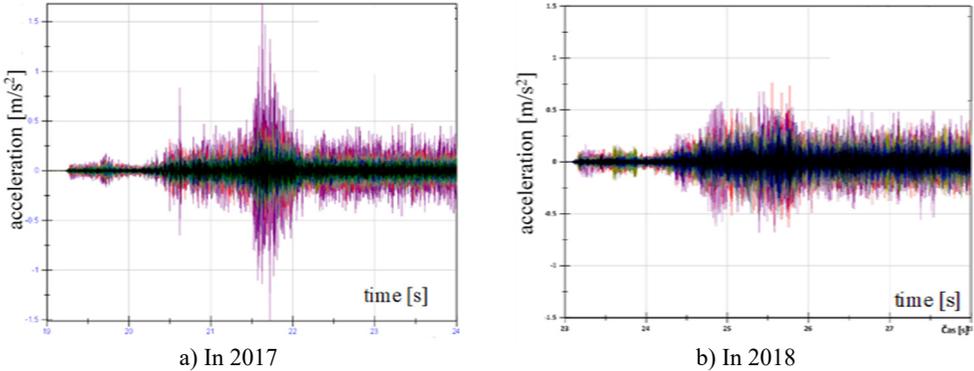
The measured acceleration amplitudes during the startup stage of the generator decreased in comparison with the previous tests in 2017 (Table 2, Fig. 5). Therefore, we could state, that the elastic shock absorber layer under the base of the generator was effective.

Fig. 5. Accelerations during startup stage

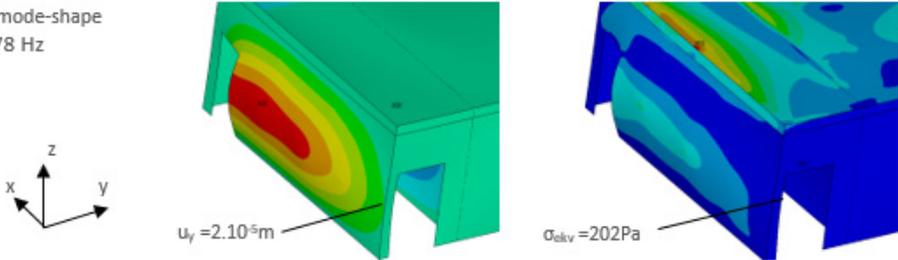
6th mode-shape
 29.78 Hz

Fig. 6. Maximum displacement in the Y direction and appropriate equivalent stresses from harmonic analyze (6th mode-shape)

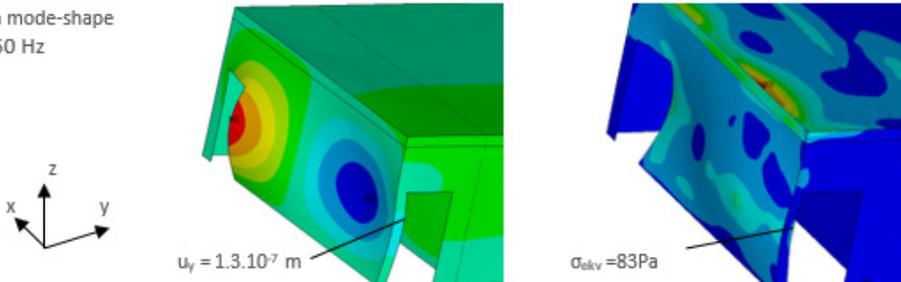
12th mode-shape
 39.50 Hz

Fig. 7. Maximum displacement in the Y direction and appropriate equivalent stresses from harmonic analyze (12th mode-shape).

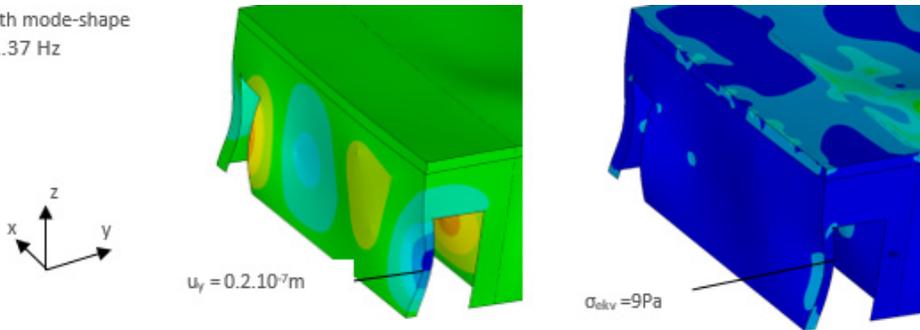
29th mode-shape
 81.37 Hz

Fig. 8. Maximum displacement in the Y direction and appropriate equivalent stresses from harmonic analyze (29th mode-shape).

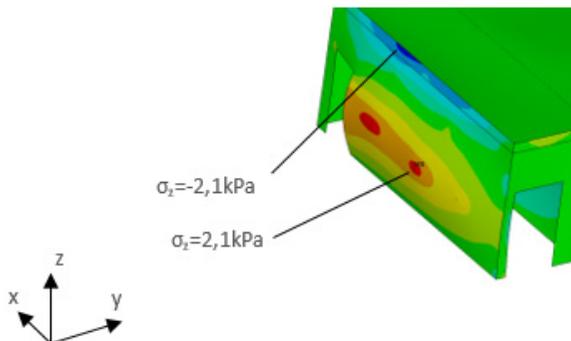
Considering the wall vibrates in several mode-shapes at the same time, each displacement which belongs to one of the three selected natural frequencies (Figs. 6-8) must be combined. We simplified the problem and added largest effects within this combination (Fig. 9). Therefore, the resulting greatest displacement caused by the acoustic pressure is about in hundredth of millimeters. Besides that, we approximately estimated the greatest values of acceleration which reached about 0.7 m/s^2 .

Fig. 9. The maximum equivalent stresses (the combination of three mode-shape)

If we evaluate a value of 0.7 m/s^2 at frequencies between 30 Hz and 75 Hz using [7, 8] then the possible effects can be classified in Category D, i.e., highly perceptible for people (and could

be further investigated in accordance with [9]) and permissible for buildings. However, it can cause emerging of small cracks in the masonry during this stage.
