Influence of gear grip quality on noise levels of gearbox

Elias Tomeh¹, Tomáš Oudrnický²

Technical University in Liberec, Liberec, Czech Republic

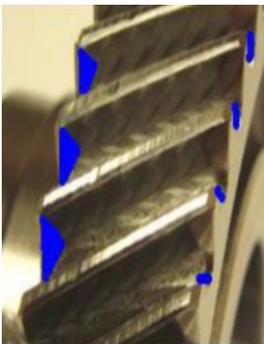
Fig. 3. a) Addendum supporting colour and b) dedendum supporting colour [1]

c) Addendum/dedendum supporting colour (Fig. 3)

This type of supporting colour is given by an incorrect profile of the tool. It is being solved by a profile modification. Addendum/dedendum supporting colour is dangerous because of the appearance of pitting (big pressure in a small area – Hertz pressure); and in terms of noise it is one of the worst cases.

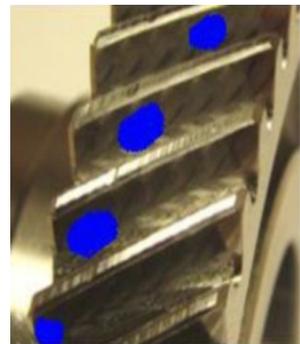
Fig. 6. Crossing trace [1]

f) Crossing trace.

Crossing traces can appear along the helix (Fig. 6) but also along an involute. This happens owing to a big circumferential runout F_r . Possible causes: eccentric hole, heat deformations, badly fixed workpiece in the machine. It is demonstrated by a fluctuating character of vibrations.

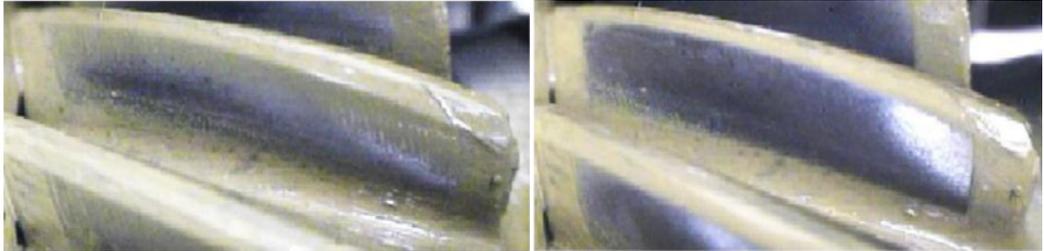
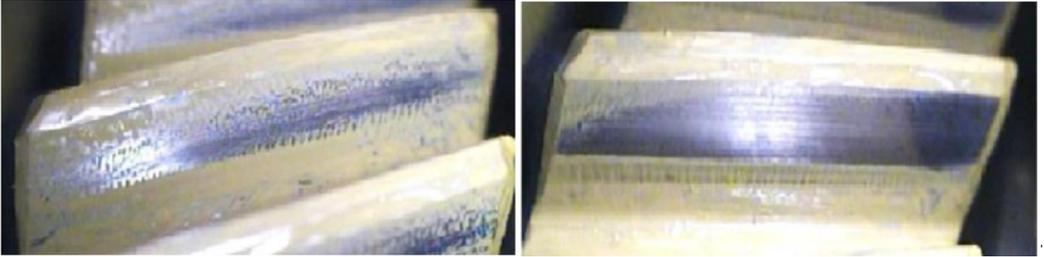
Fig. 8. Tracing 1° backward – proposal

a) $M_{MOT} = 0$ Nm a 20 Nm, 1° driving (Festrad), right side

b) $M_{MOT} = 0$ Nm a 20 Nm, 1° driven (Schaltrad), left side

When comparing the results of the previously made calculation and the results of the practical tracing test, we can state that the results correspond. Compared with the serial type of the construction, the trace and the edge supporting colour – which negatively influenced the traces on the serial type of the construction – were reduced. Due to the extension of the lateral barrel gearing, the “full supporting colour” was changed into “mirror supporting colour” which is characteristic for big values of barrel gearing.

Especially when simulating the zero load ($M_{MOT} = 0$ Nm), the difference is clearly visible. The trace of the supporting colour was considerably reduced and it also changed its shape from an angular shape of the full supporting colour to an elliptical shape of the mirror supporting colour. In this regime, the edge supporting colour was also completely removed.

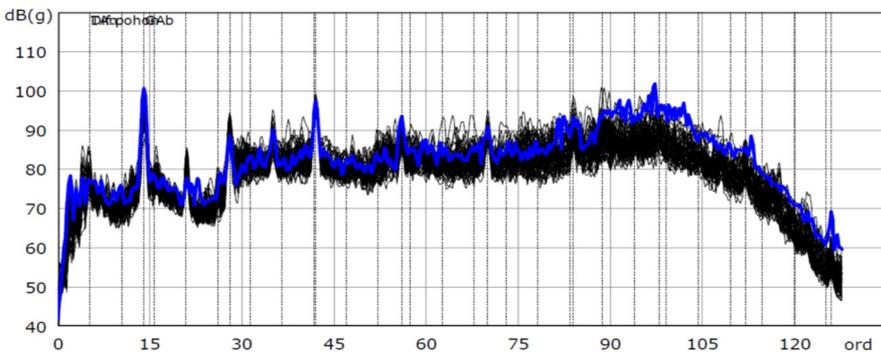
Fig. 9. Results comparison from EOL – the whole spectrum

through a so-called test bench (EOL). The following graphs are the results of the order analysis from this noise level in the regime of the first gear on the backward side. The figure allows us to see the differences between the gearbox and new, proposed modifications (blue curve) and serial measuring of safe gearboxes from the same day (black curves).

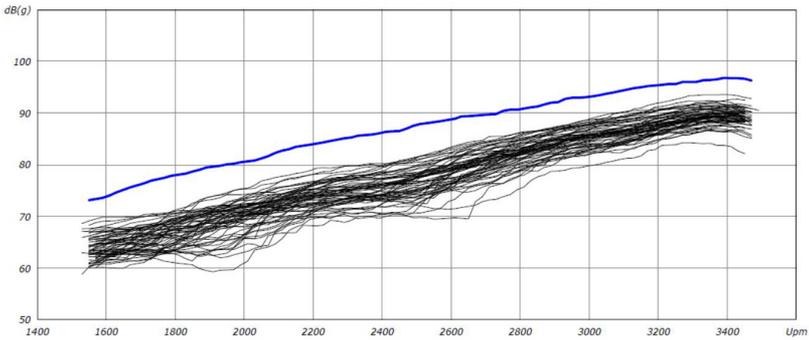
Fig. 10. Results comparison from EOL – amplitude of first harmonic frequency

In the following figures, we can see the comparison of the amplitude size of the first harmonic frequency (Fig. 10) and the second harmonic frequency (Fig. 11) depending on the speed of the gearbox drive shaft.

The results clearly show that – with increasing speed – the amplitude of the first harmonic frequency increases on a linear basis. Modified gearing shows the increase of this amplitude by an average of 5 to 10 dB in comparison with the serial type of the construction of the gear.

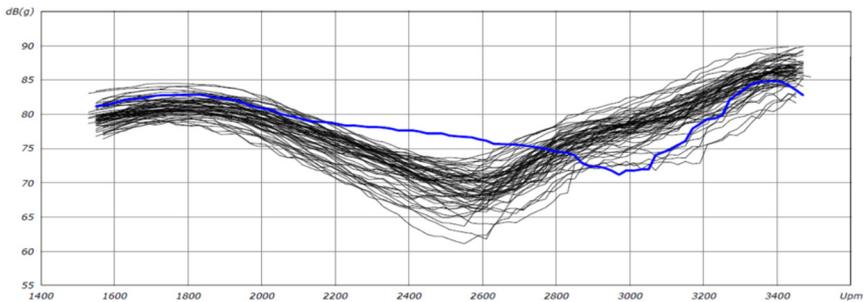
Fig. 11. Results comparison from EOL – amplitude of second harmonic frequency

The second harmonic frequency has a slightly different course. We can observe a local

minimum of the values of the amplitude which is – in serial type of construction – ranged between 2400 and 2700 min^{-1} . When considering the modified type of construction, it is slightly moved to higher speed. As for the amplitude size, the results are comparable in low speed, higher in middle speed and rather lower in high speed – as shown in the graph.

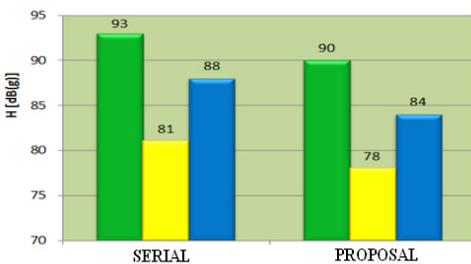
Fig. 12. Amplitudes of acceleration comparison: green – first harmonic frequency, blue – second harmonic frequency, yellow – first interharmonic frequency

1) Graph in the Fig. 12 compares the amplitudes of acceleration of the first and second harmonic frequencies, including the interharmonic one.

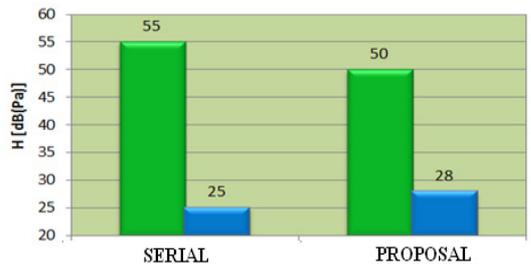
Fig. 13. Amplitudes of sound pressure comparison: green – first harmonic frequency, blue – second harmonic frequency

2) Graph in the Fig. 13 compares the amplitudes of the sound pressure of the first and second harmonic frequency from the driving test, from the microphone. The first harmonic frequency of the sound pressure in the vehicle cab was reduced by 5 dB. Therefore, the noise impact on the vehicle crew was slightly reduced as well.
